**Fire Hazard Analysis
Building 901A
Tandem Van De Graaff**

Brookhaven National Laboratory

Date of Last Survey: March 29, 2004
Date of Report: June 2007

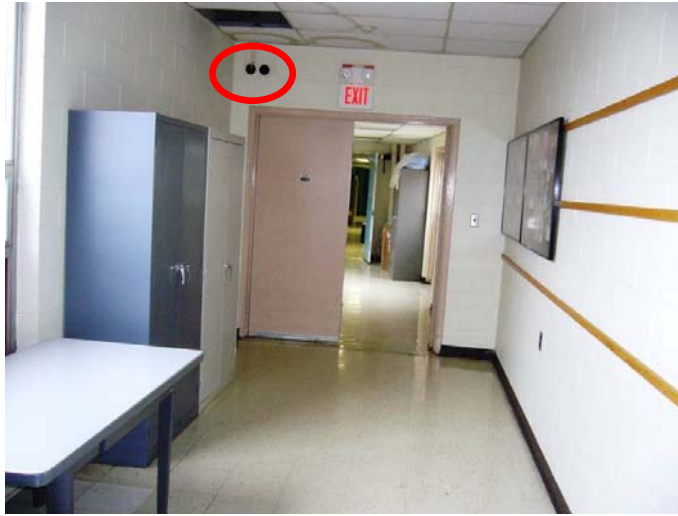
Photograph #3– Unprotected Opening

Finding: There is an unprotected opening between Building 901A and Building 901.

Hazard Severity	III
Mishap Probability	C
Risk Assessment Code	4

Recommendation HAI-07-901A-05: The opening should be sealed with a listed/approved fire barrier product, listed/approved for this type of penetration. (See Section 4.3.1)

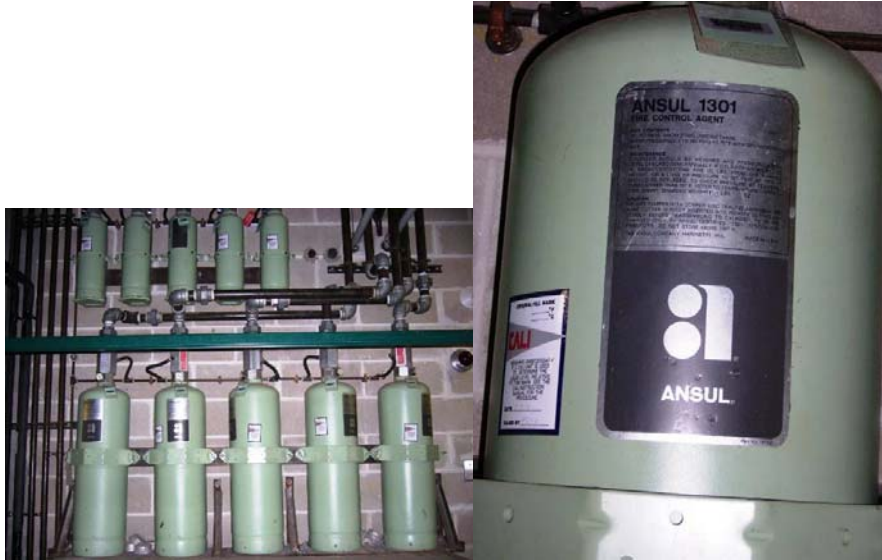
Photographs #4 and #5– Halon 1301 System

There are two Halon 1301 gaseous fire suppression systems in the building. Halon 1301 (bromotrifluoromethane, CBrF₃) is a colorless, odorless, electrically nonconductive gas that is an effective medium for extinguishing fires. The systems protect the control room and the computer room located directly below the control room. The Halon cylinders are located in the mechanical room in the basement. There are four 90 pound cylinders for each room and four 18 pound cylinders for each sub-floor space. Release of Halon requires two rate of rise heat detection zones to be activated. An abort switch is located near the Ansul AutoPulse IQ-301 control panel.

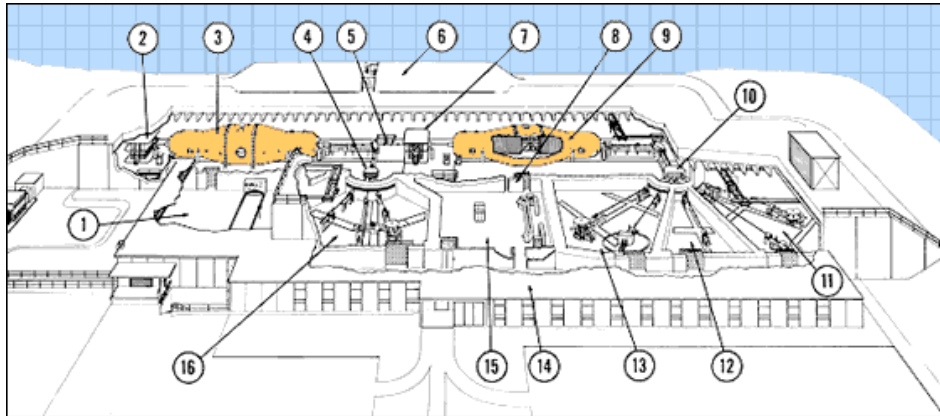
Sketch #1 – Tandem Van De Graaff's - Cut away view

Sketch #1 is a cut-away view of the first floor of the Tandem Van de Graaff facility that show the two Van de Graaff electrostatic accelerators (3) and (9) each independently capable of accelerating a wide variety of ion species from external ion sources (2) and (7) through beam switching magnets (4) and (10) into target rooms (11), (12), (13) and (16). Highest particle energies are achieved in a three-stage operation with the first accelerator (3) injecting energetic negative ions through the connecting link (5) directly into the second accelerator (9). The accelerators are operated from the centrally located control room (15) which has direct access to the accelerator rooms through one of the shielding doors (8). The mechanical equipment room (1) contains the pumps and compressors necessary to transfer insulating gas from storage tanks (6) to each accelerator pressure vessel. Laboratory and office space (14) is available for resident and visiting scientific personnel.

The accelerators are about 100 feet long and 18 feet in maximum diameter. The accelerators are located in line in a room of fire resistive construction about 320 feet long by 35 feet wide. The room has a basement area used for the storage of spare equipment. Combustibles are limited.

Each accelerator contains 11,250 cubic feet of an insulating gas made-up of a 50/50 mixture of nitrogen and sulfur hexafluoride at about 150 psig surrounding the support column and accelerator tube, which is maintained at a high vacuum (13 atm of pressure). The injection voltages for the ion sources are developed for each unit by two insulated core transformers located in the basement area under the accelerators. The insulating gas is supplied by 79 tanks, each 80 feet long, buried in the earth cover above the units.

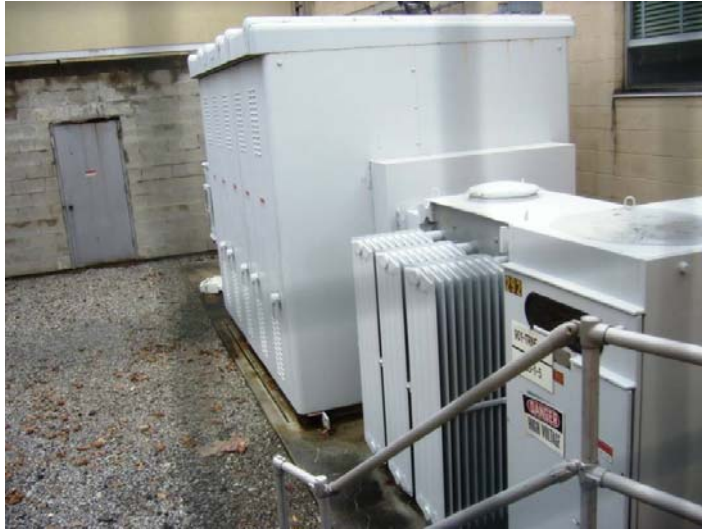
Photograph #8 Transformers

The transformers and switchgear are arranged to comply with the recommendations contained in Factory Mutual Loss Prevention Data Sheet 5-4 for fire protection. The transformers do not present an exposure hazard to the facility or to each other.

The 1500 KVA transformer utilizes 550 gallons of a high flash point fluid. The 200 KVA transformer uses 550 gallons of a high flash point fluid. They are located in a containment system consisting of dikes and rock fill.
